Products: EVC300/EVC350/EV900/EVC950

Firmware Version: 00.10.18.04

Published Date: March 6th, 2022

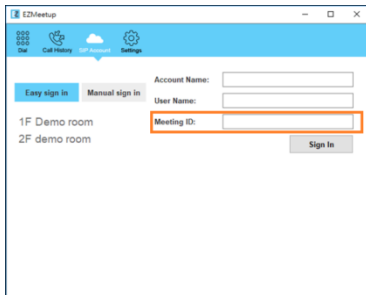
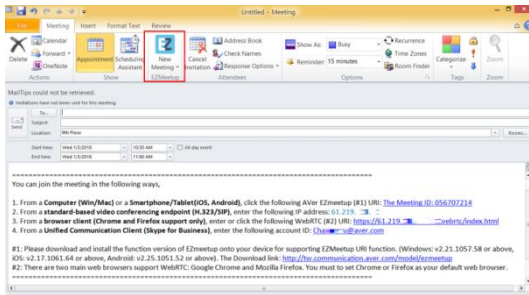
2. Support Meeting ID method, after upgrading this new firmware, EVC will auto get an exclusive own number of Meeting ID, the Meeting ID can be used for EZMeetup Easy sign-in EVC SIP server, also for Outlook add-in to schedule EVC meetings (EZMeetup v2.21.1057.61 or above). <div style="display: flex; justify-content: space-around;">

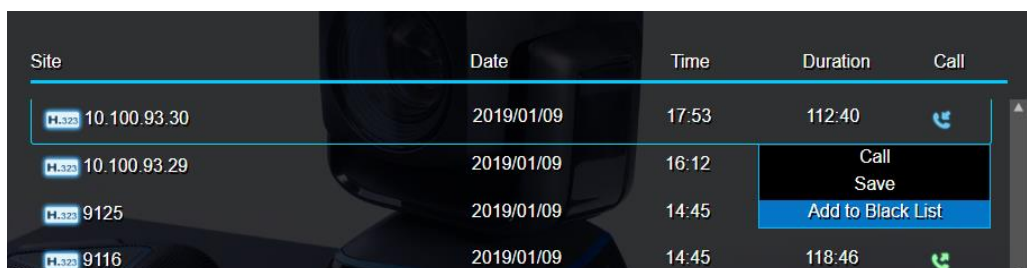
5. Blacklist management: To filter out specific IP and annoying Spam calls, you can add in blacklist list from the call history page. Please go to Phonebook > Blacklist management

Site	Date	Time	Duration	Call
H.323 10.100.93.30	2019/01/09	17:53	112:40	
H.323 10.100.93.29	2019/01/09	16:12		<ul style="list-style-type: none"> Call Save Add to Black List
H.323 9125	2019/01/09	14:45		
H.323 9116	2019/01/09	14:45	118:46

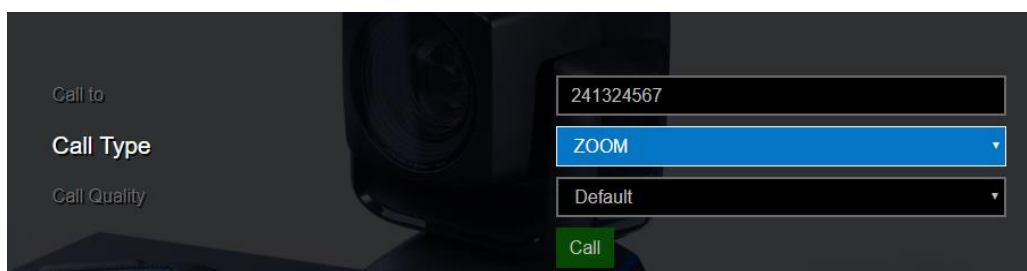
6. 3rd-Party Cloud Meetings: For H.323 3rd-party cloud call function, after enabling this function, you can select 3rd-party cloud meeting from the call type list, and enter the “Meeting ID” at “Call to” column to connect the H.323 3rd-party cloud meeting. For example Zoom, Bluejeans, Trueconf... Please go to Phonebook > 3rd-Party Cloud Meetings

Call to: 241324567

Call Type: ZOOM
