**Products:** VC520 Pro2 / Expansion Speakerphone

**VC520 Pro2 Firmware Version:** 0.0.7204.21

**VC520 Pro expansion speakerphone:** v0.0.8000.10

**Published Date:** June 05, 2023

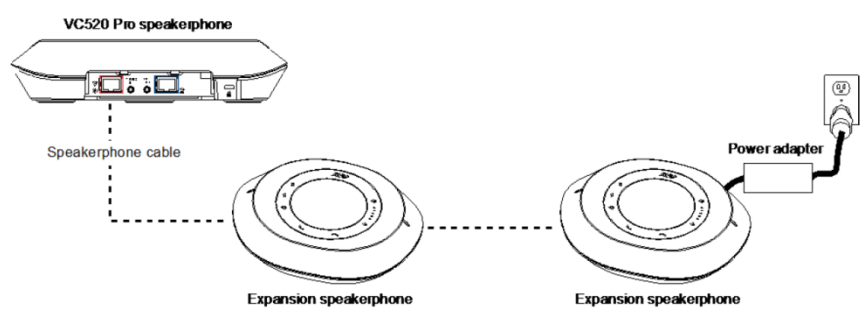
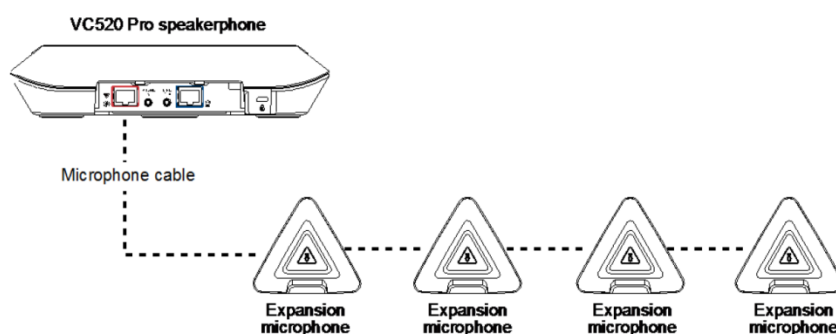
1. Requirements VC520 Pro2 Firmware version: v7200.64 or later
2. The expansion speakerphone cannot be the main speakerphone; it can only be used with the VC520 Pro2.
3. The VC520 Pro2 can support up to two expansion speakerphones, however, the daisy-chain expansion cable cannot exceed over 40m in total.
4. Please connect the power supply for the expansion speakerphone when daisy-chaining over 20m.
5. Please connect the power supply when upgrading the firmware for the expansion speakerphone.
6. The speakerphone cables and power adapter will be included in the package contents.

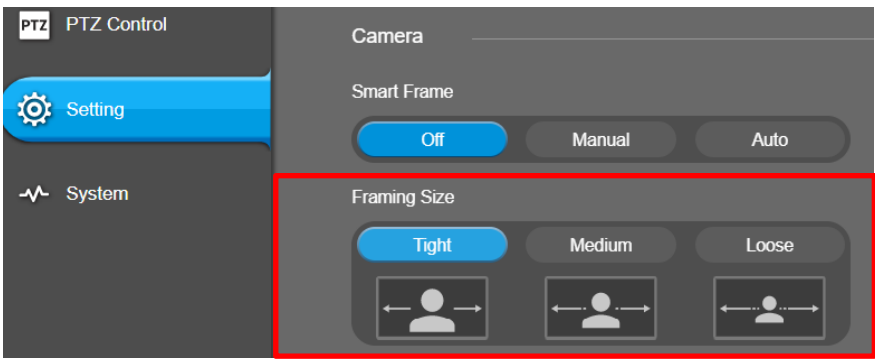
| Firmware Version | New Features |
|---|---|
| 0.0.7200.78 | <ol style="list-style-type: none"> <li>Add “framing size” function. When auto framing, the zoom in size has different options so that the new comers can be detected for different using scenario. Please upgrade PTZApp2 to the latest version to have this function.</li> </ol> |

| | <p><b>Tight</b> (default): It provides a close-up view of meeting participants.</p> <p><b>Medium</b>: It provides Establishes a medium view of meeting participants.</p> <p><b>Loose</b>: It provides a wide view of meeting participants.</p> <ol style="list-style-type: none"> <li>Change people count behavior. When streaming is off, people counting function keeps running so that 3rd party app still can get the data.</li> <li>When under auto frame mode, whenever the USB streaming is on, camera will trigger framing detection for once no matter there is people or not.</li> <li>Enhance Auto focus speed, especially when people are in front of whiteboard/ TV screen.</li> <li>Enhance WDR performance.</li> </ol> |
